BNAM 2026
Baltic-Nordic Acoustics Meeting
May 04-06 2026 Gothenburg, Sweden

Sound Intensity Measurements for Identifying Dominant Transmission Paths in Shipboard Partition Walls

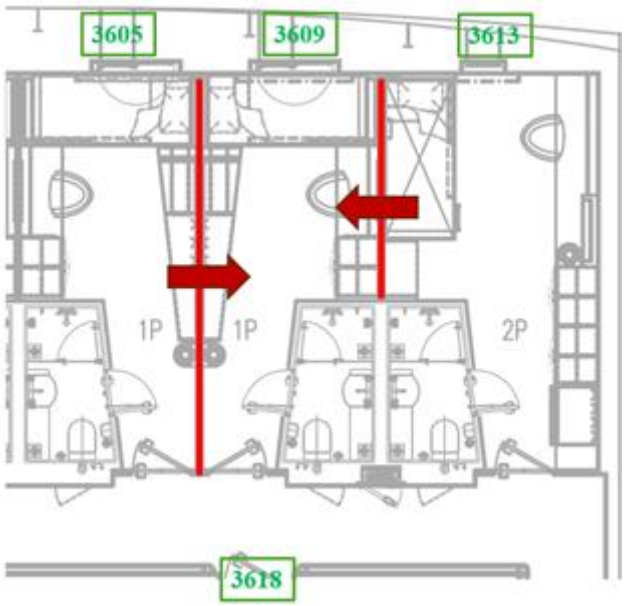
Figure 3: Configuration 1 – partition walls between cabins

The first configuration consists of a cabin-to-cabin partition separating two adjacent accommodation spaces. The partition wall extends over a relatively large uninterrupted surface without sanitary units or other stiffening elements. Such partitions are typically constructed as lightweight panel systems within the vessel's interior structure, which may result in relatively low structural stiffness. See Figure 4 for the drawing of this first configuration.

The resulting 3D sound intensity vector field showed a relatively uniform distribution of radiated sound energy across a large portion of the partition wall surface. This behaviour indicates that the partition wall panels were excited over a significant area and contributed to sound transmission through distributed panel vibration. No clear localized transmission points were observed within the scanned area. The results therefore suggest that the acoustic performance of this partition is dominated by the global structural response of the partition wall rather than by specific weak points or discontinuities.

This observation is consistent with the structural characteristics of the investigated partition wall configuration. The partition extends over a relatively large uninterrupted area and does not contain additional structural elements that would increase its stiffness. As a result, the partition wall panels can radiate sound over a broad surface when excited by airborne sound in the source room. This can be observed in Figure 6 by the red vectors, which present a high intensity. The white part in the picture is a mirror. In addition, the vectors are predominantly oriented away from the corridor side towards the hull, indicating a net energy flow through the partition wall consistent with distributed panel radiation.

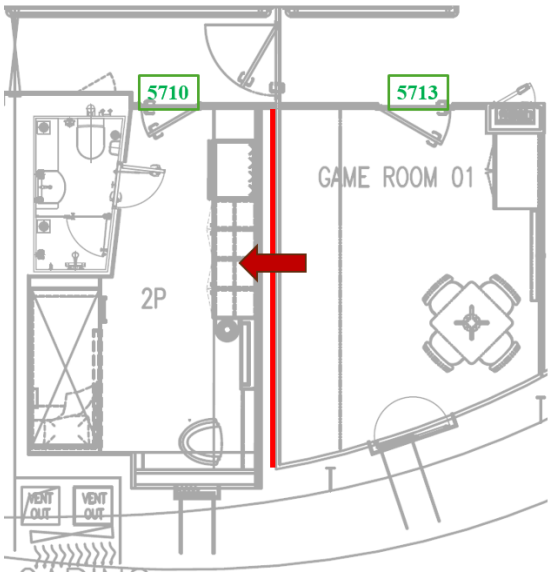
Figure 4: Configuration 2 – partition between cabin and public space

The second configuration concerns a separation between a public space and an adjacent cabin. In addition to the primary partition wall, this configuration includes ventilation inlet and outlet elements connected to the vessel's ventilation system. These elements introduce service penetrations through the separating structure and may influence the overall sound transmission behaviour. See Figure 5 for the drawing of this second configuration.

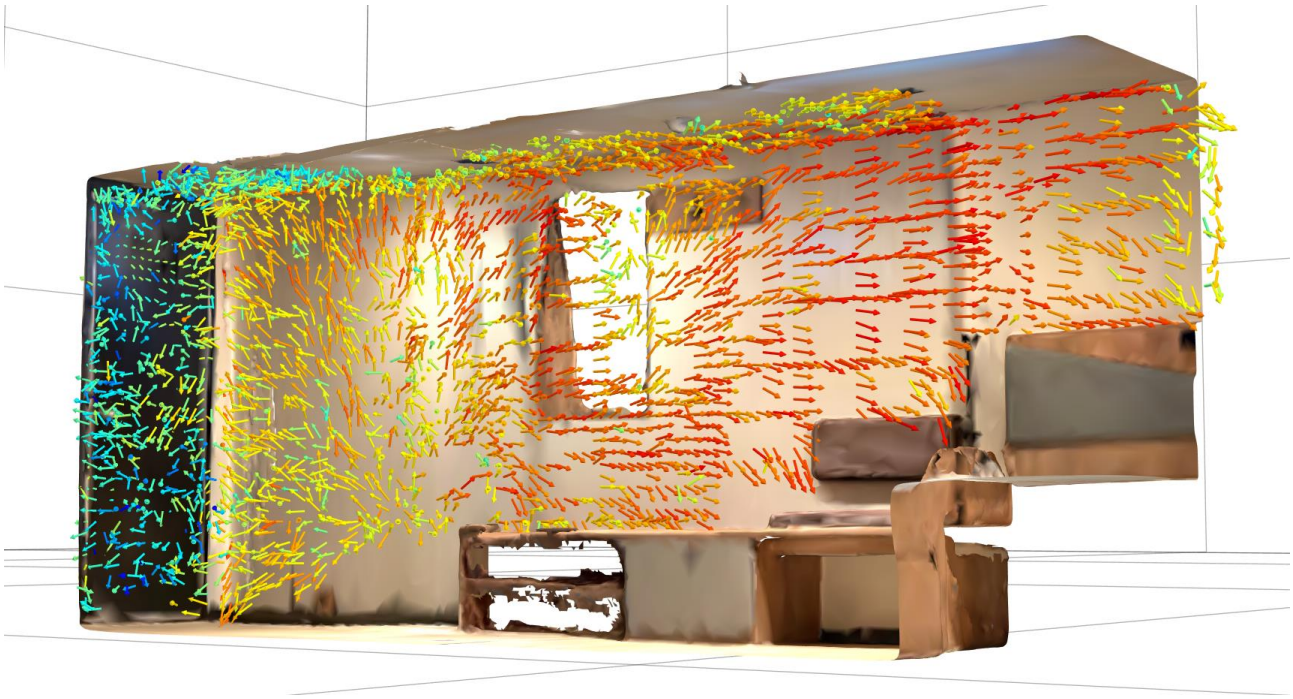
Figure 5: Sound intensity distribution on the cabin-to-cabin partition (configuration 1) for the frequency area of 1500-3000 Hz

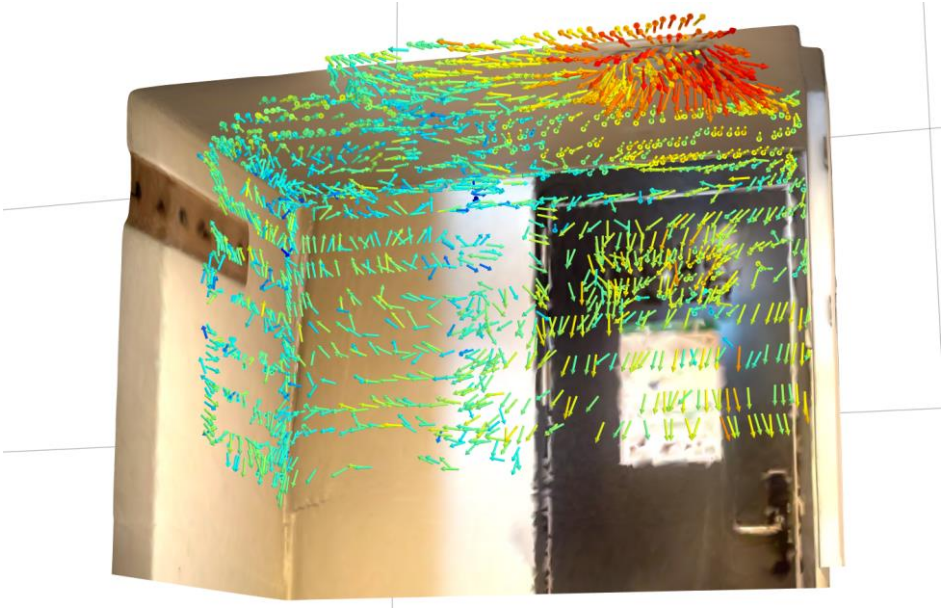
The sound intensity maps revealed that most of the transmitted acoustic energy was concentrated around the ventilation inlet and outlet elements. In contrast to the cabin-to-cabin partition, the surrounding partition wall surfaces showed relatively low levels of radiated sound energy. This indicates that the dominant transmission paths were associated with the ventilation components rather than with the partition wall panels themselves. The vectors near the ventilation opening show a clear outward and spatially distributed orientation, indicating that the airflow path acts as a localized source of transmitted acoustic energy into the cabin.

The results demonstrate that service penetrations such as ventilation openings can act as locally governing acoustic weak points in otherwise well-performing partition constructions. The measurements clearly illustrate how spatially resolved sound intensity techniques can identify such localized transmission paths, which are difficult to detect using conventional sound insulation measurements alone.

Figure 6: Sound intensity distribution on the public space-to-cabin partition (configuration 2) for the frequency area of 100-3000 Hz
